# **Telex Dispatch Mini PC**

# Telex Mini PC Boot, BIOS and SSD reset instructions

| Revision History | | |
|---|---|---|
| <b>Document Number:</b> AN-DISPATCH-Min PC | | |

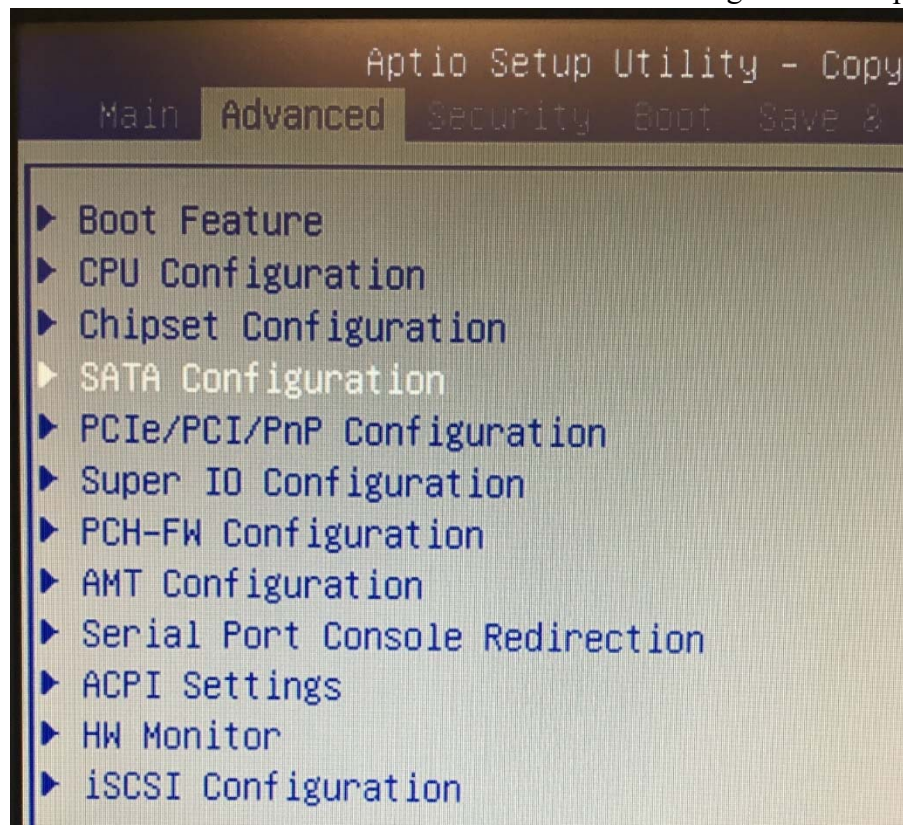
See if the SSD drive is listed as Serial ATA Port 0, if yes continue to next step. If not, power the PC down and remove power. Open the case and manually check the SATA cable attached to the SSD drive. Push the cable in a little bit and close up the case.

Power the PC back on and re-enter BIOS. Is the SSD shown? If not the PC needs to be replaced and you should contact Bosch Parts and Repair Department., otherwise continue to next step.

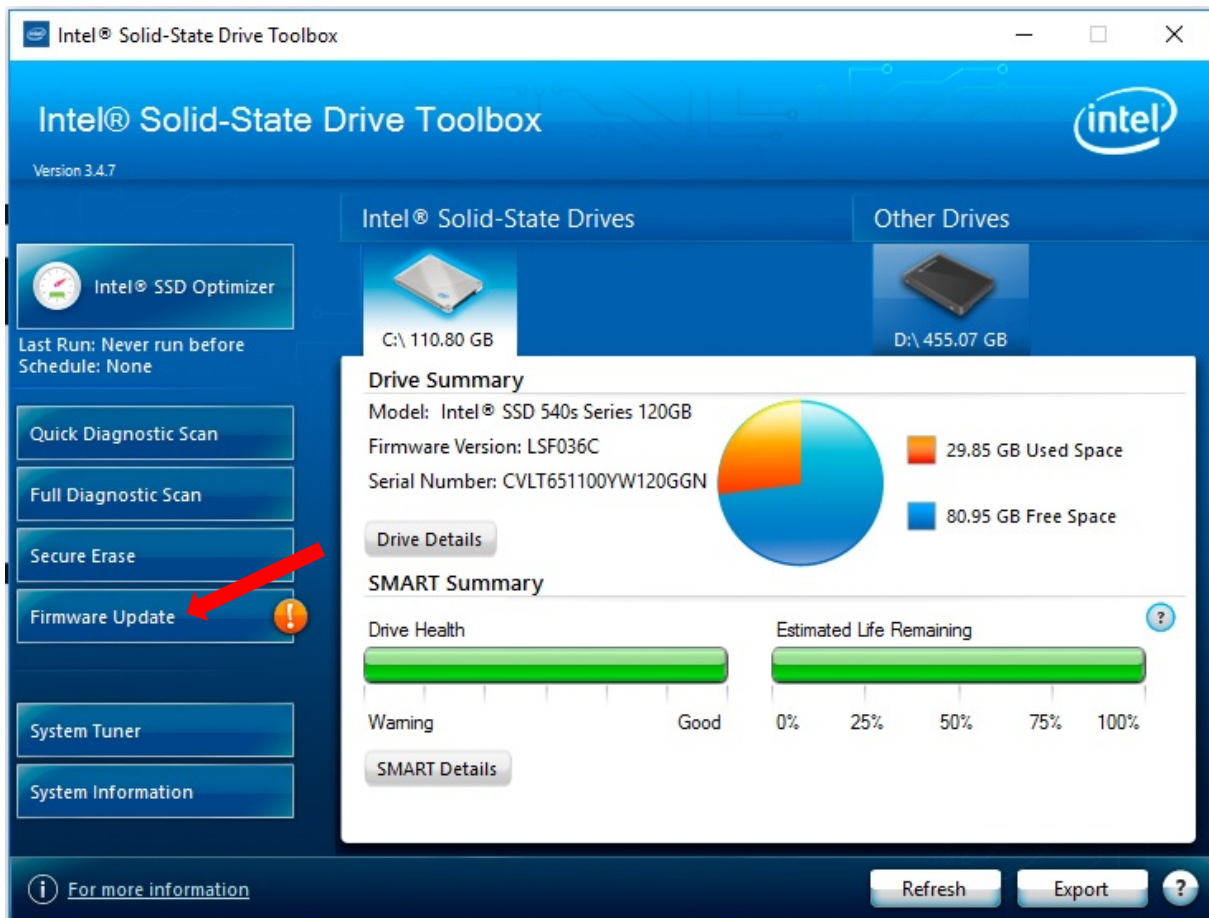
Now that the PC is booting correctly we want to minimize any chances of the issue reoccurring. A major issue in the Intel SSD firmware LSF036C for SSD 540s series hardware has been found that might be the cause of this. Your PC may have a different model SSD so please run the application to check for any firmware updates. We would like your help by completing the following steps:

1. Install the Windows Application for Firmware Upgrade - <https://downloadcenter.intel.com/download/27130?v=t>
2. Update the SSD drive firmware to LFS041C or newer, red arrow.

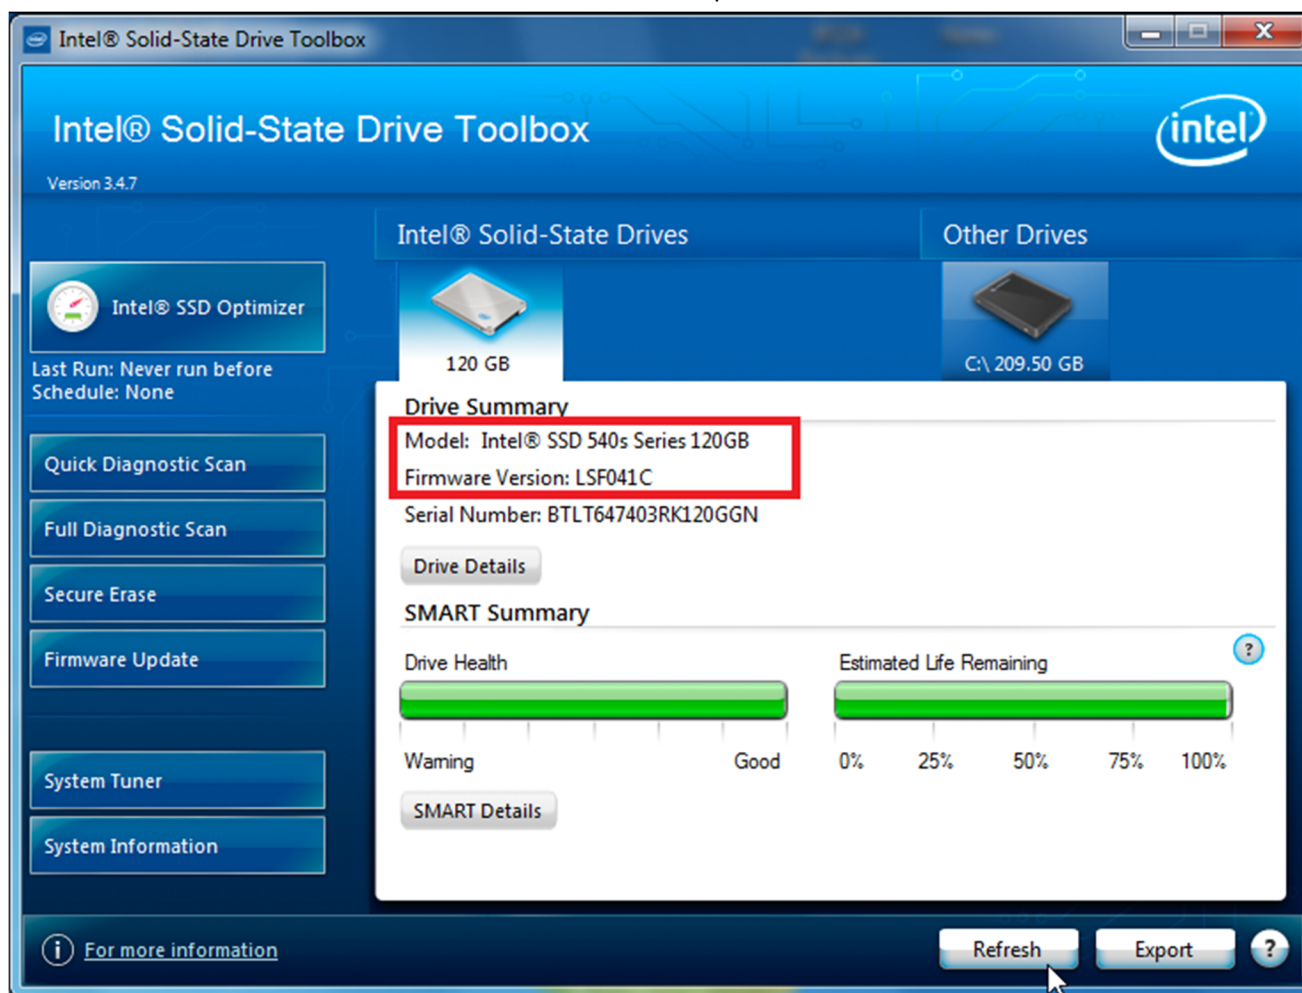
- Please see the screen shot below for a view of an updated SSD
