# **Telex Dispatch Mini PC**

# Telex Mini PC Boot, BIOS and SSD reset instructions

| Revision History | | |
|---|---|---|
| <b>Document Number:</b> AN-DISPATCH-Min PC | | |

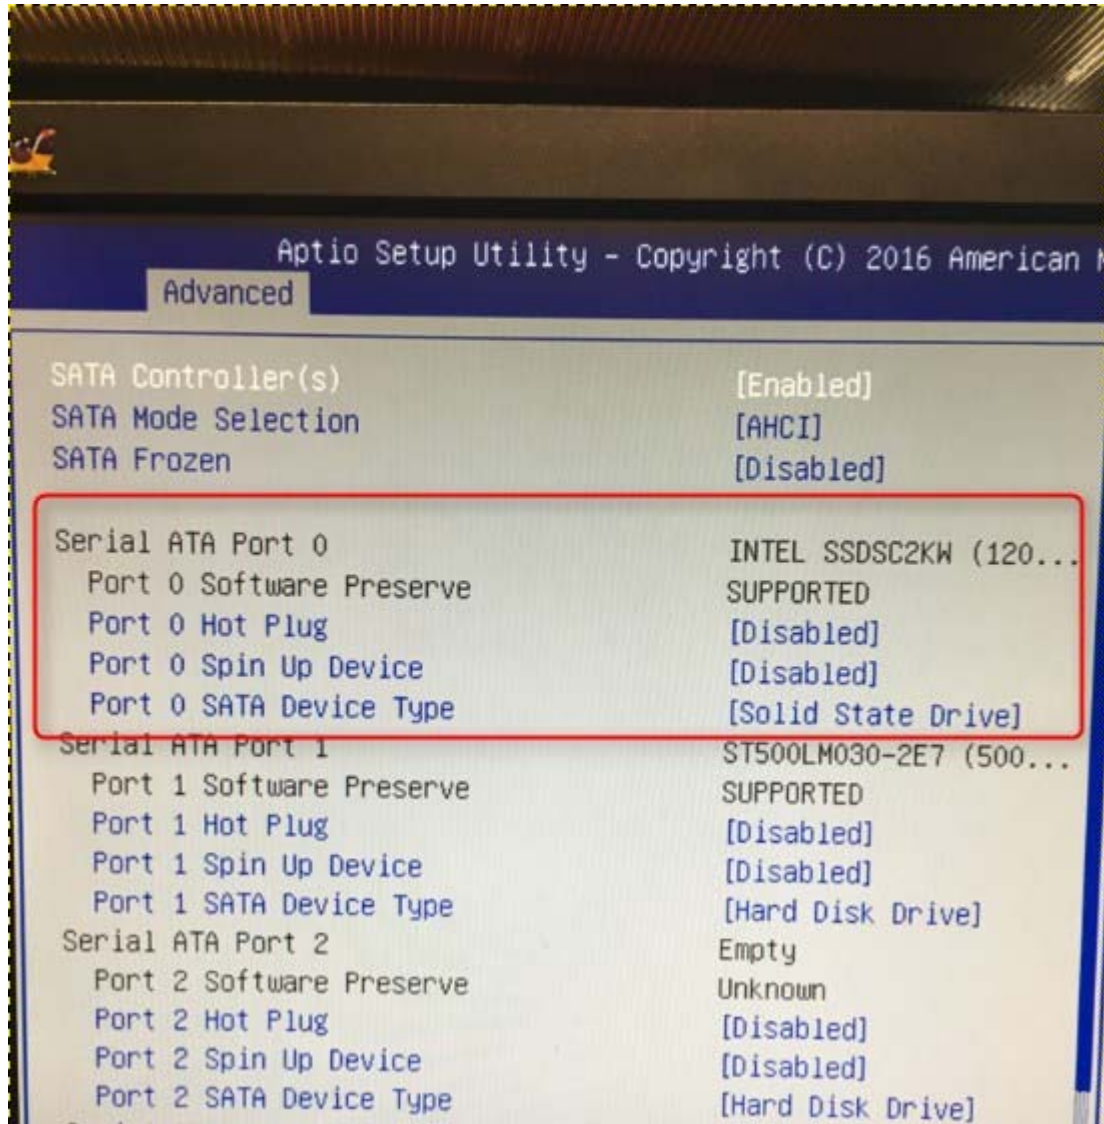
See if the SSD drive is listed as Serial ATA Port 0, if yes continue to next step. If not, power the PC down and remove power. Open the case and manually check the SATA cable attached to the SSD drive. Push the cable in a little bit and close up the case.

Power the PC back on and re-enter BIOS. Is the SSD shown? If not the PC needs to be replaced and you should contact Bosch Parts and Repair Department., otherwise continue to next step.

Once the SSD is seen you can then go to the boot menu, Press ESC key to exit SATA setup.

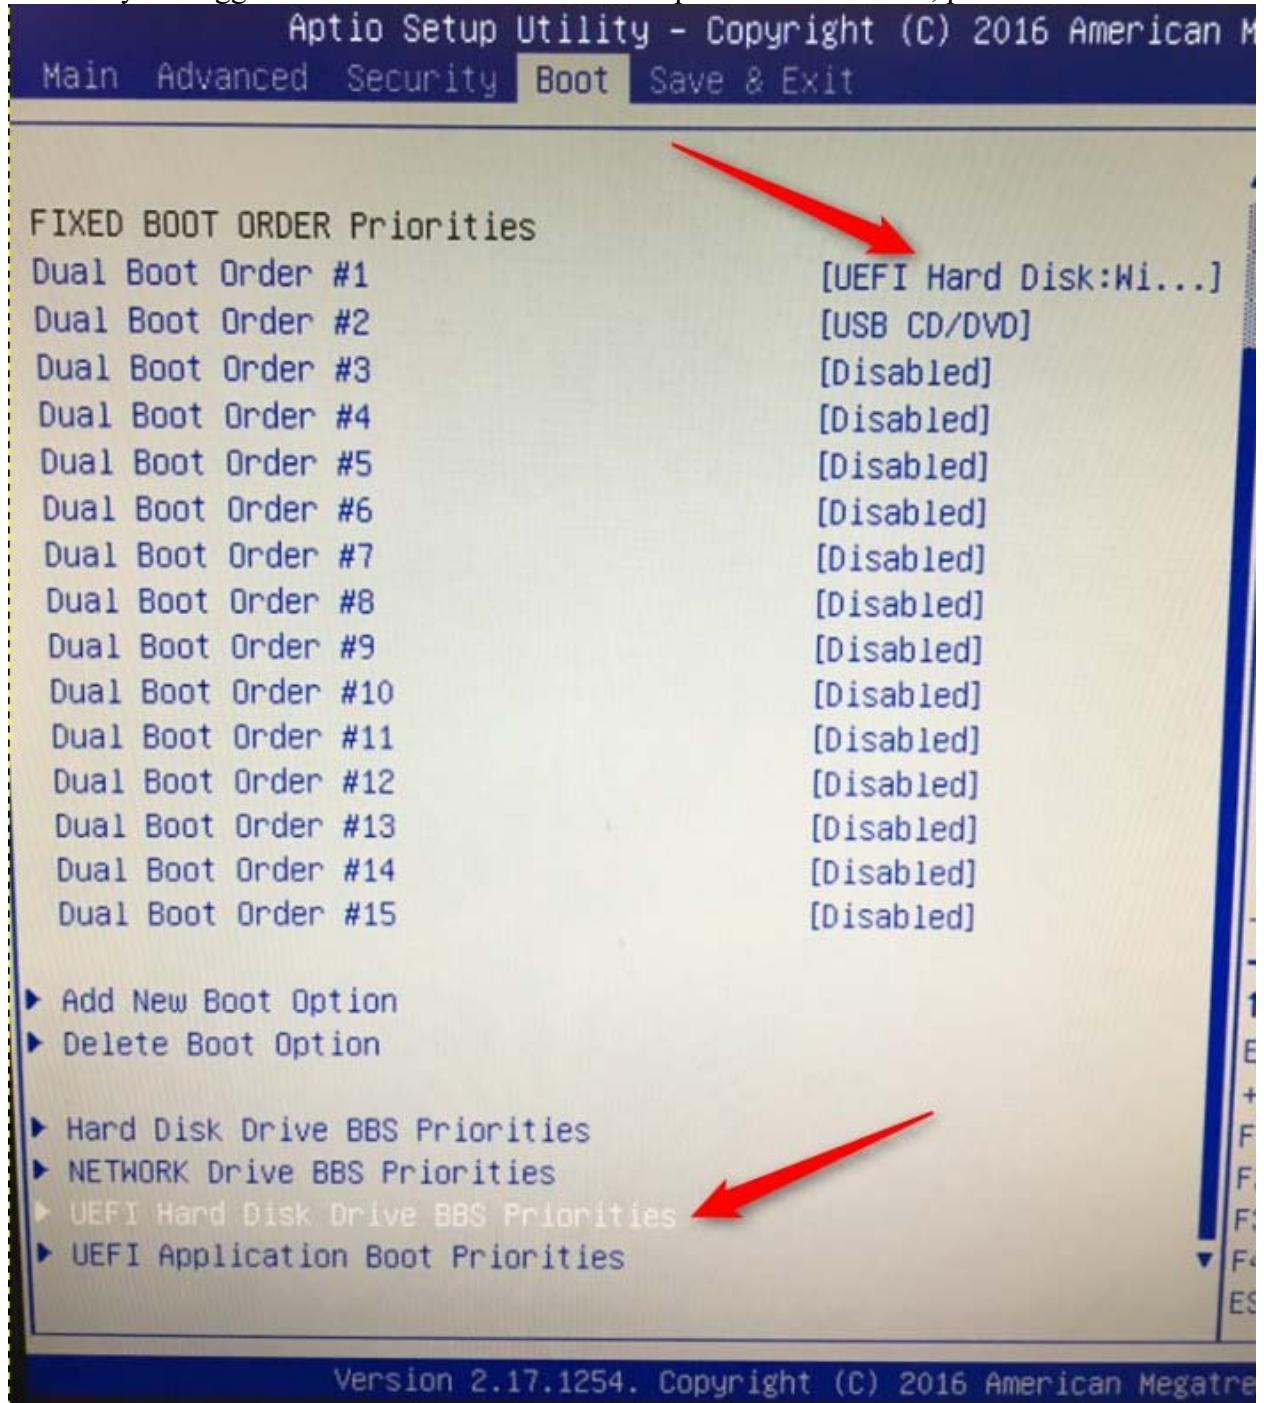
Make sure Dual Boot Order #1 has UEFI: Hard disk:Windows boot manager.

If you don't see this option, you will need to change the UEFI hard disk BBS priorities. Use arrow keys to toggle down till UEFI hard disk BBS priorities is selected, press Enter.
